RICS  
**HomeBuyer Report**

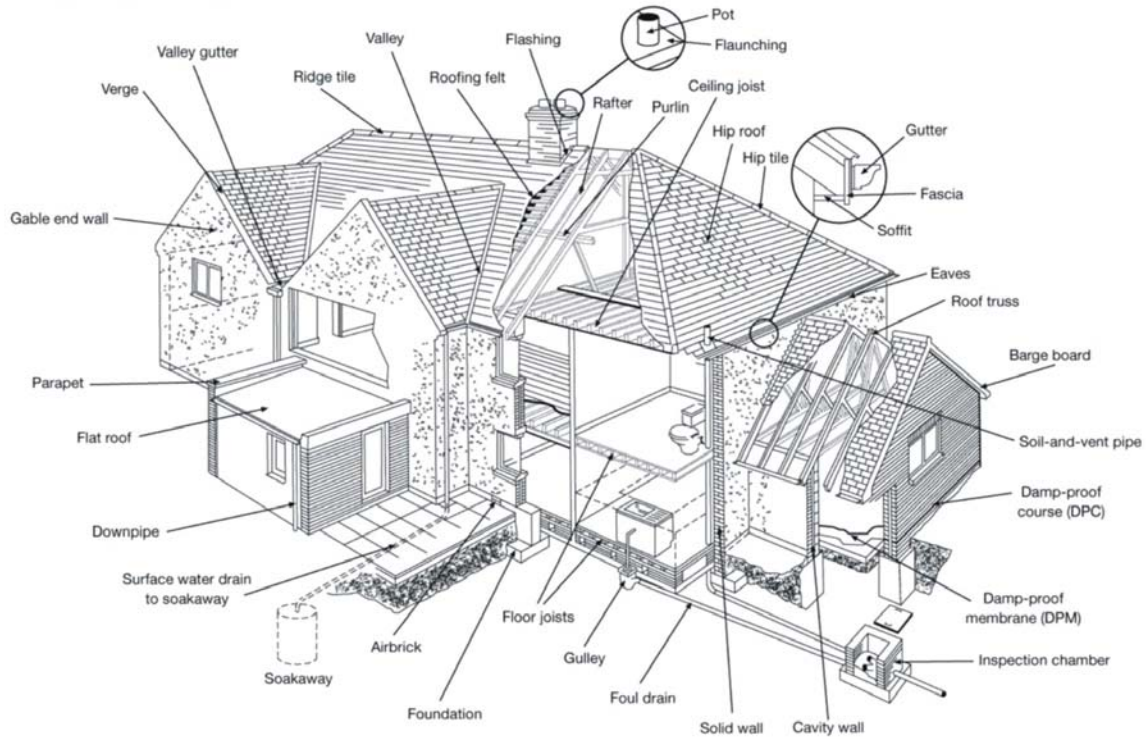
This diagram illustrates where you may find some of the building elements referred to in the report.
